**Tree-Ring Analysis of Timbers from Howbury Barn,  
Moat Lane, Slade Green, London Borough of Bexley**

Dr Martin Bridge

**Summary**

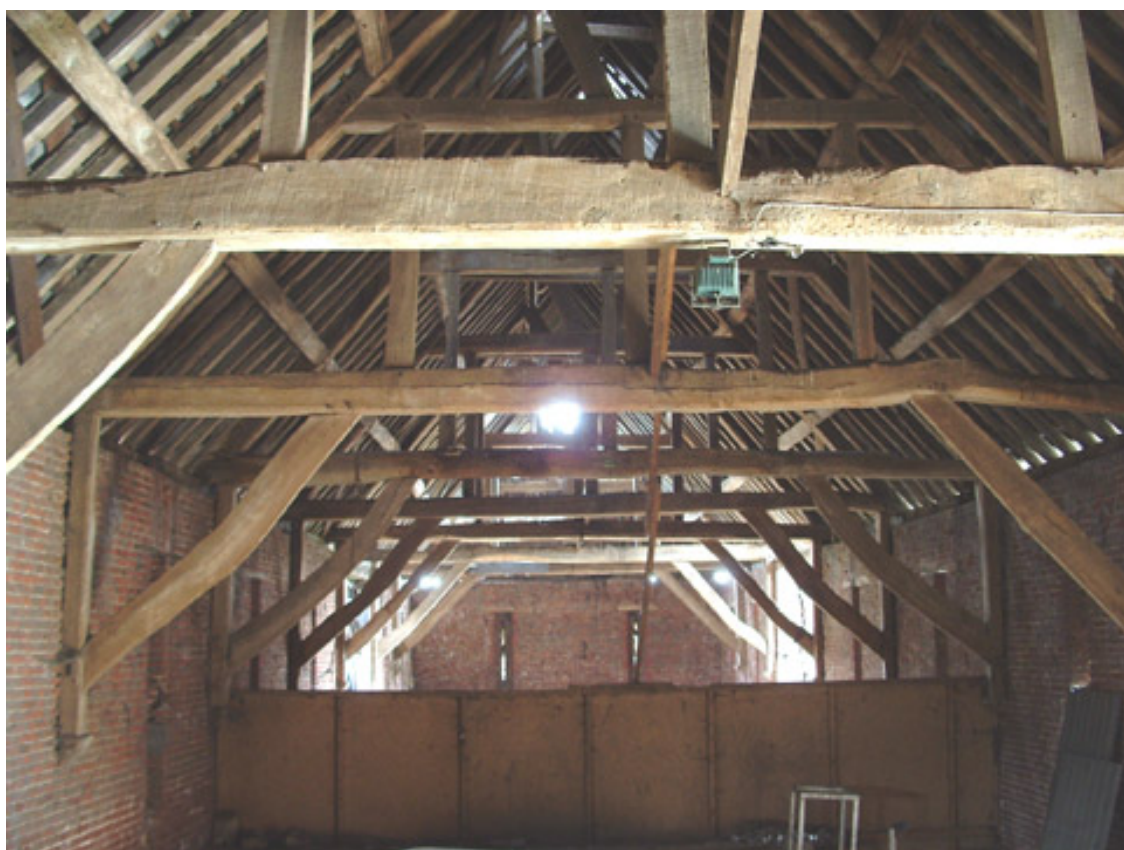
**Figure 2:** View from the platform at the west end, looking east

Sampling was limited by access, many of the timbers being too high to access via a ladder. A platform in the western-most two bays allowed some access to timbers in these bays, although its floor was unsafe in parts. Access was not available on this visit to the tiebeams other than those at the western end, although these appear from ground level to be made from fast-grown trees, as perhaps can be seen in the photograph (Fig 2). It was felt that sufficient sampling was possible on this visit to show the general nature of the timbers and therefore the likelihood of a second visit, with a means of accessing the high timbers, resulting in more positive results. After discussion with members of the Scientific Dating Team, English Heritage, it was decided that further sampling could not be justified at this stage.

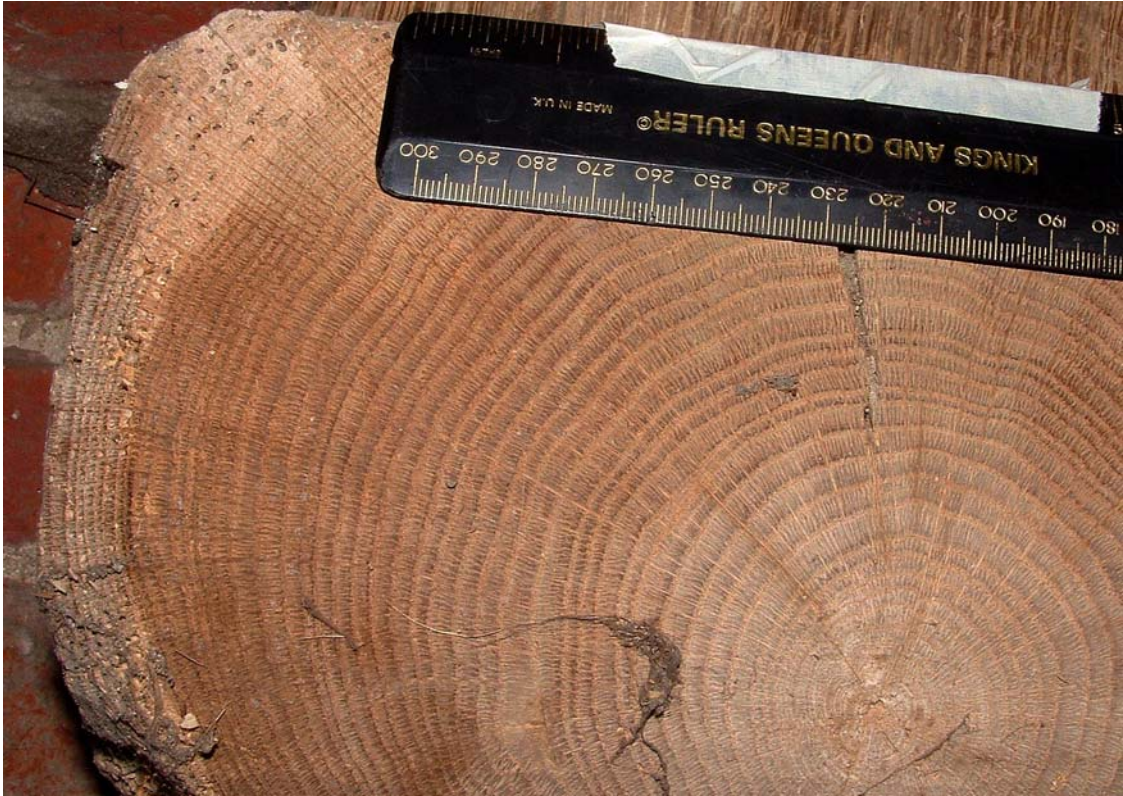
**Figure 3:** Photograph of **HOW06**, the corbel to truss 7 on the south side

The site was visited in May 2005. In the initial assessment, accessible oak timbers with more than 50 rings and traces of sapwood were sought. Those building timbers judged to be potentially useful were cored using a 15mm auger attached to an electric drill. The cores were glued to wooden laths, labelled, and stored for subsequent analysis. One timber had a clean cut end, and this was photographed along with a crude scale (Fig 3). Subsequent analysis of this sample was by measuring direct from the photograph.

\* - see Figure 3
