**BROCTON WWI ARMY CAMP,
CANNOCK CHASE, STAFFORDSHIRE
AN INVESTIGATION OF THE WINDOW GLASS
TECHNOLOGY REPORT**

AN INVESTIGATION OF THE WINDOW GLASS

NGR: SJ 9755 1865

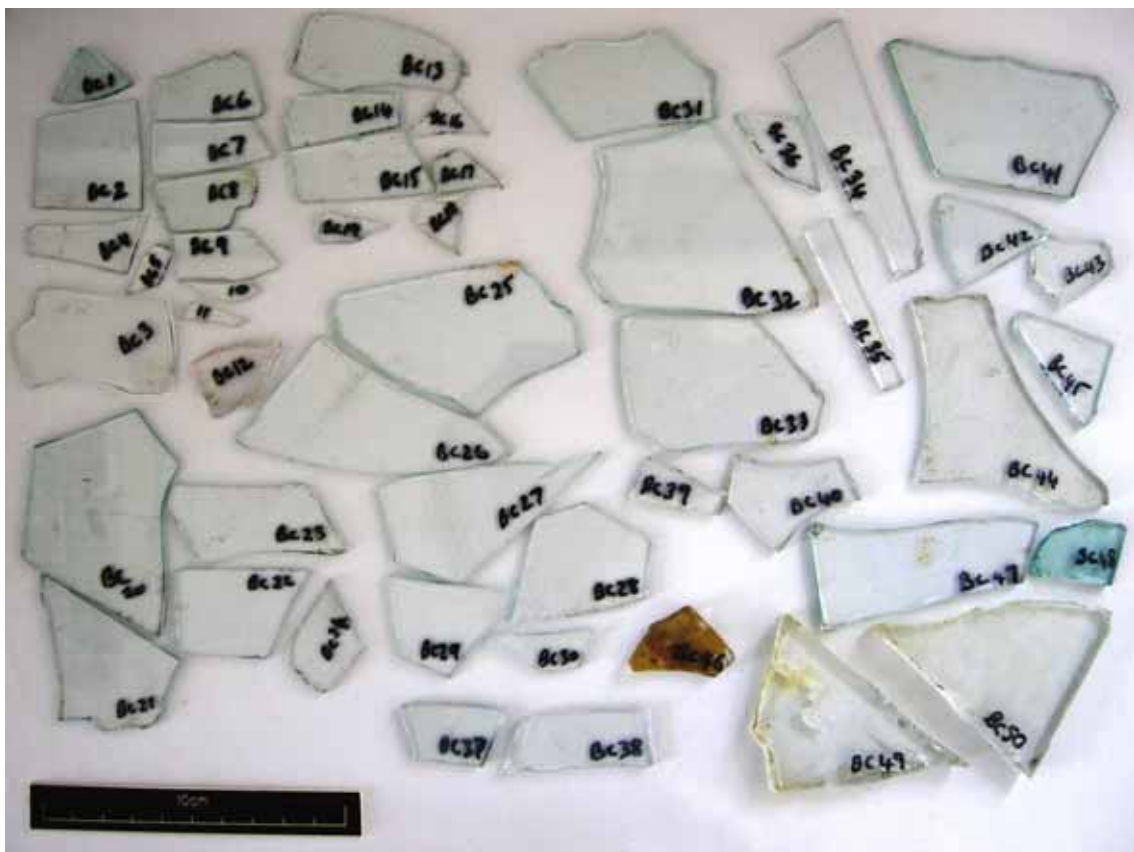
The majority of the samples of glass are very pale green and flat or very flat window glass. Two of these samples are slightly melted or burned (BC 03 and BC 46). One also has a yellow surface corrosion (BC46). Three samples were bottle glass, one pale green (BC 01), one a darker green (BC 48) and one clear (BC 12). The two 7mm thick samples of glass (BC 49 and BC50), considered to be plate glass are clear.

Figure 2. All 50 samples of glass

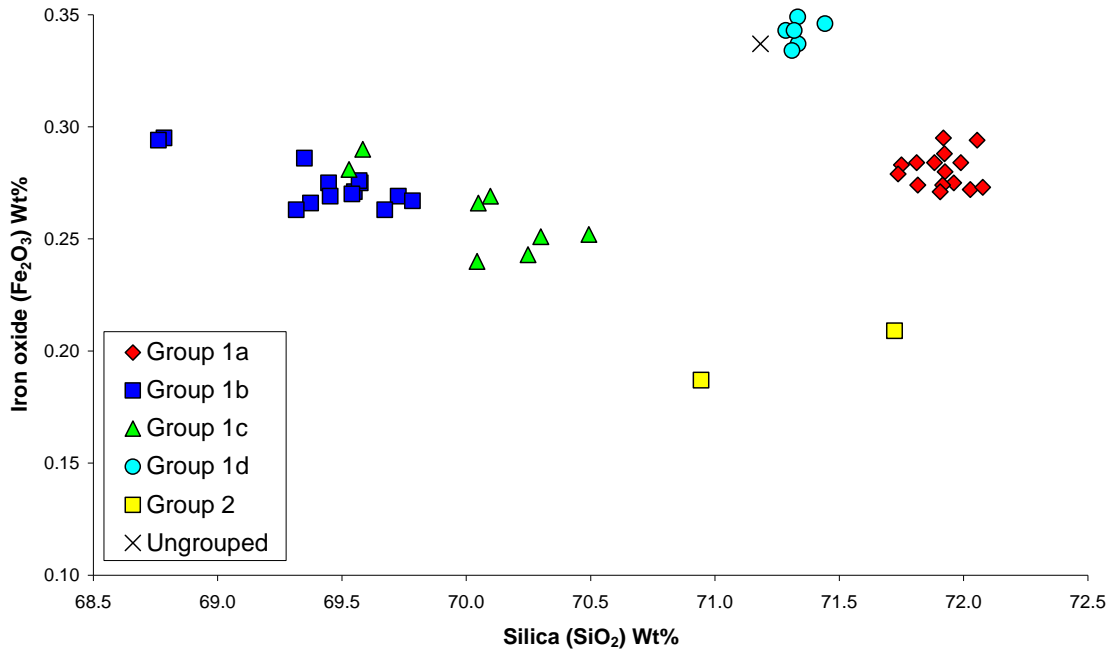
Figure 4: Silica (SiO₂) and iron oxide (Fe₂O₃) comparison of the Brocton Camp window glass

All fifty samples of glass from Brocton Camp are soda lime glass. The samples have been divided into several compositional groups: Group 1 (sheet glass), Group 2 (plate glass) and bottle glass. The sheet and plate glass samples are all made of good quality materials containing low concentrations of impurities (for full chemical results see Appendix 2). The sheet glass samples are very similar in composition, and all but one of them can be placed into four sub-groups: Groups 1a, 1b, 1c and 1d (see Figures 3–5). These different Groups have compositions which are subtly distinct: Group 1a has the lowest soda, Group 1b has the highest lime and Group 1c has the highest soda (Figure 3). Group 1d is subtly different in composition as it contains rather more iron, notably less potassium, but includes traces of arsenic (see Figures 4 and 5). Group 1d comprises the two samples of thick (7mm) plate glass. Sample BC02 is sheet glass but does not match the compositional groups identified; it is similar to Groups 1a, 1b and 1c but has a higher iron content (see Figure 4).

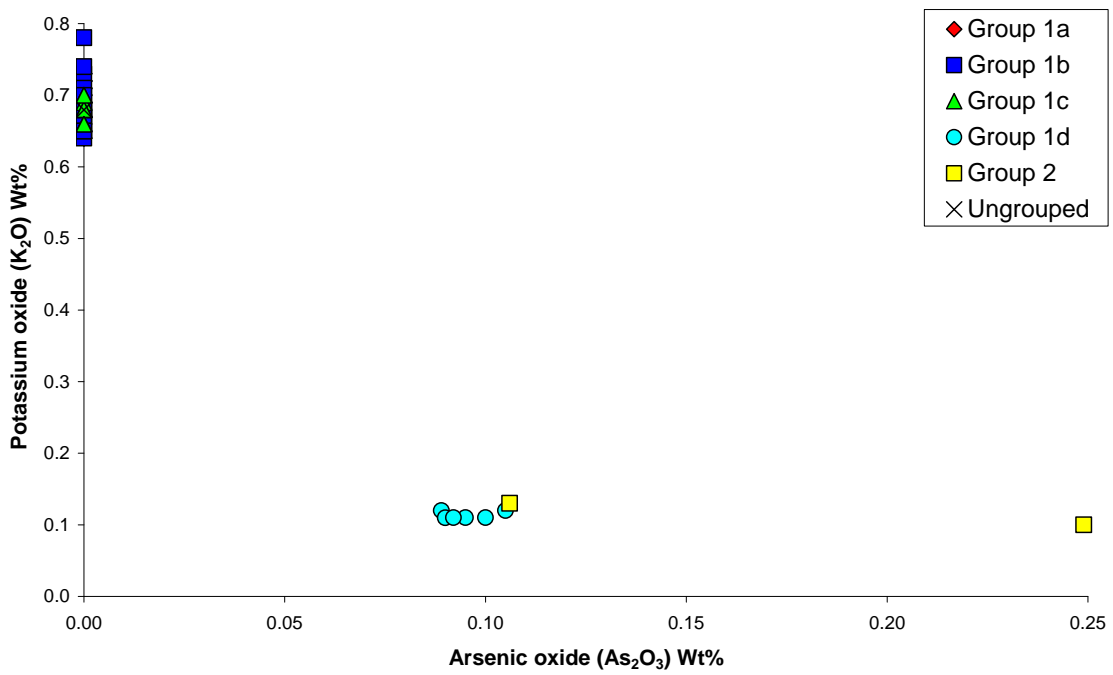
Figure 5: Arsenic oxide (As₂O₃) and potassium oxide (K₂O) comparison of the Brocton Camp window glass. Note Groups 1a–1c contain less than 0.03wt% As₂O₃

Groups 1a to 1c are made of high-quality materials with low impurities and show no traces of magnesia thus fitting most satisfactorily to the composition expected of early 20th-century window glass. Group 1d however is subtly different with a higher iron and less potassium with traces of arsenic. Significant arsenic has so far generally been missing from analysis of all post mid 19th-century window glass (See Table3).
